**ARCHEOLOGICAL SURVEY FOR BRIDGE REPLACEMENTS
ON COUNTY ROAD 39 IN VICTORIA COUNTY, FM 532
IN LAVACA COUNTY, FM 951 IN DEWITT COUNTY,
AND FM 108 IN GONZALES COUNTY, TEXAS
CSJ NOS. 0913-27-051, 1007-03-017, 0839-04-010, and 0715-02-013**

TECHNICAL REPORT NO. 92

Texas Department of Transportation
Environmental Affairs Division
Archeological Studies Program
Austin, Texas

Prewitt and Associates, Inc.
Cultural Resources Services
Austin, Texas

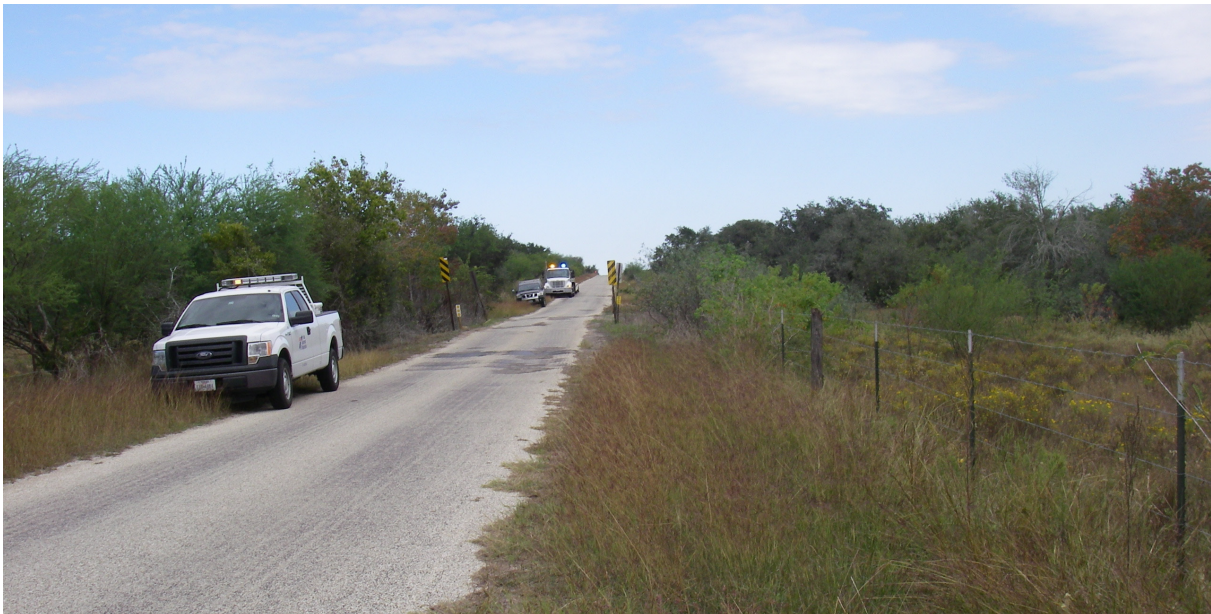
Figure 2. View to the north-northeast of the CR 39 project area.

The CR 39 project area crosses a shallowly incised unnamed stream in a rural upland setting (Figure 2). The stream, dry at the time of the survey, flows from northwest to southeast to its confluence with Garcitas Creek. The surface elevation is ca. 160 ft across the project area.

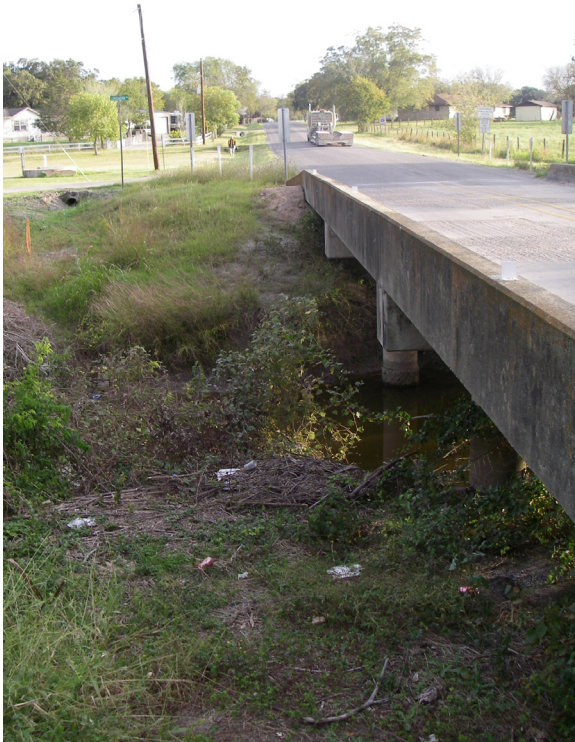
Figure 3. View of the bridge and northeast approach in the FM 532 project area, with the town of Moulton beyond.

The FM 532 project area is on the floodplain and adjacent lower valley margins of the West Prong of the Lavaca River on the southwest edge of the town of Moulton (Figure 3). Water

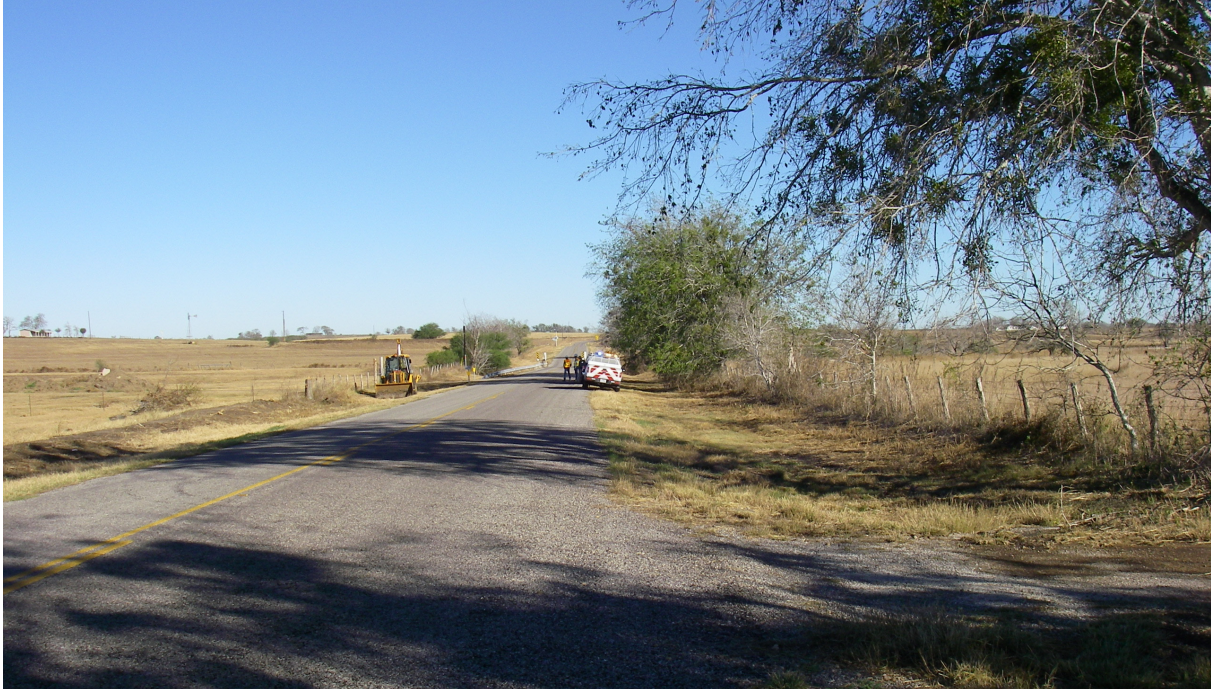
Figure 4. View to the north of the FM 951 project area.

The FM 951 project area crosses the shallowly incised, intermittent North Fork of Queens Creek in a rural upland setting (Figure 4). Water was present in the creek at the time of the survey but not flowing; the stream flows from northeast to southwest. Surface elevations are ca. 300 ft across the project area.

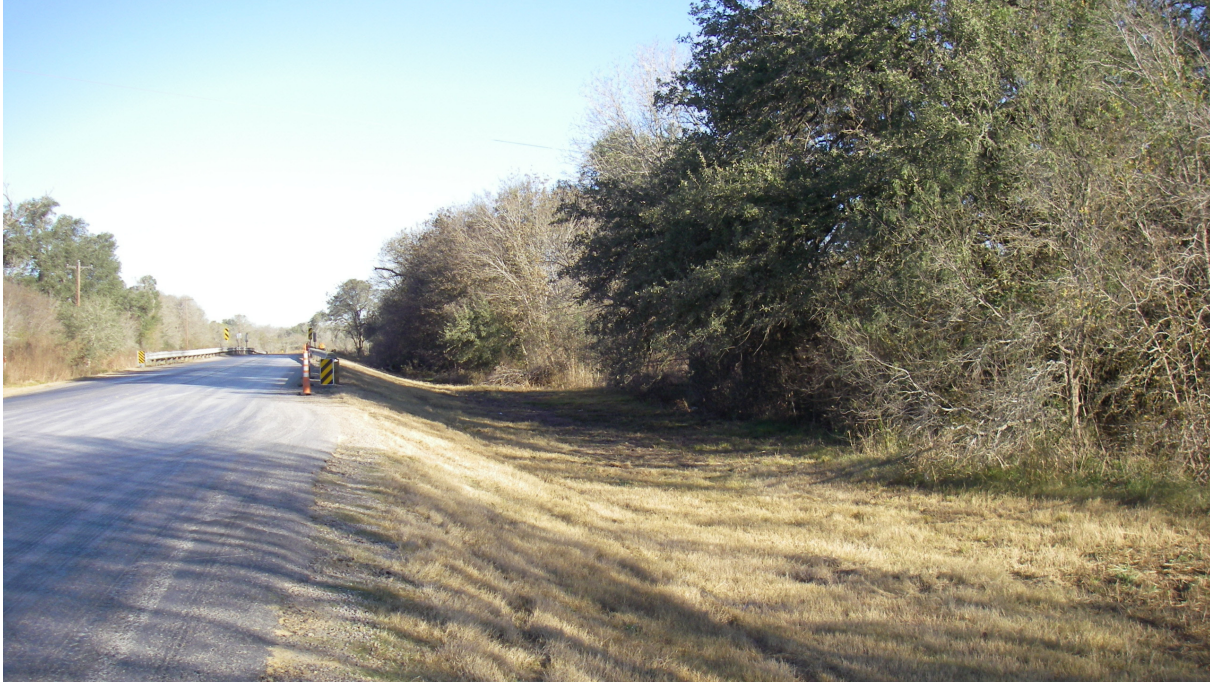
Figure 5. View to the north of the east side of the FM 108 project area south of the bridge.

The FM 108 project area is on the broad, flat floodplain of Elm Creek south of the town of Smiley (Figure 5). The bridge to be replaced crosses a secondary channel ca. 0.6 km south of the main Elm Creek channel. Water was present and flowing at the time of the survey. The stream flows from west to east to its confluence with Elm Creek proper. Surface elevations are ca. 245–250 ft across the floodplain.

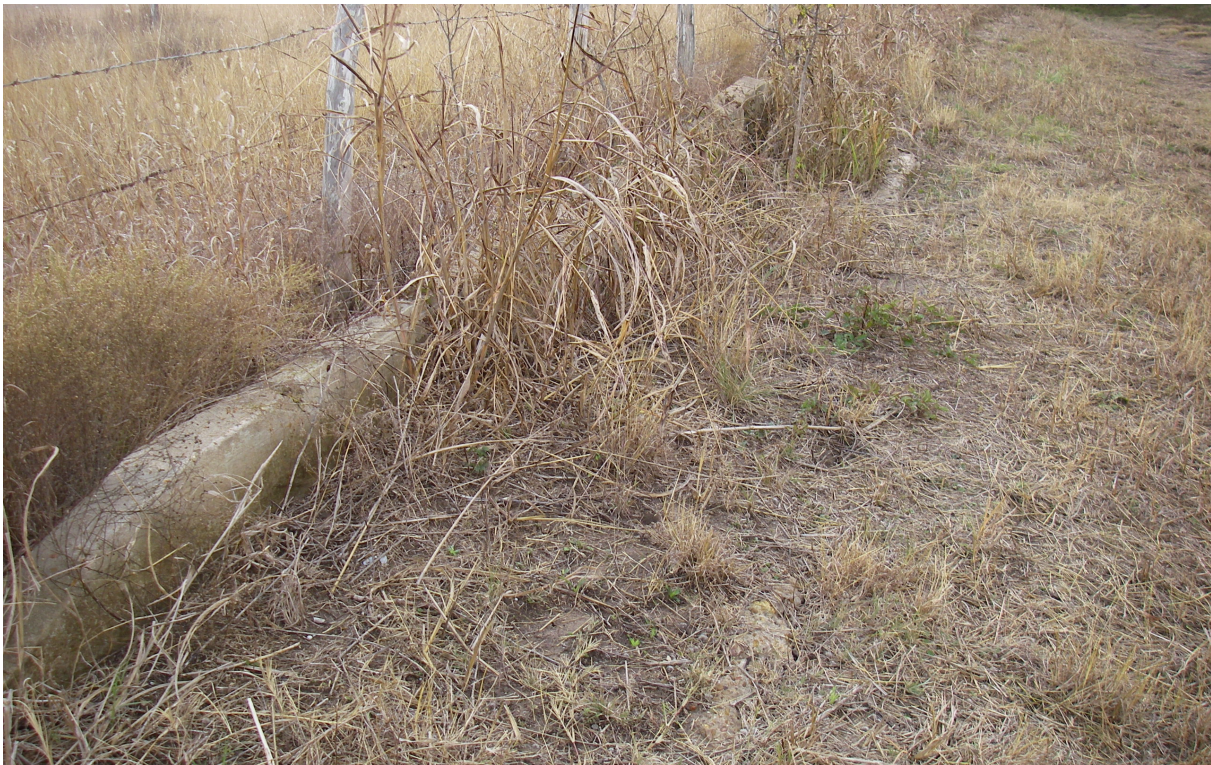
Figure 9. View to the south-southeast of remains of cattle-dipping vat along the east edge of the FM 951 project area.

No archeological materials were observed on the surface or in any of the seven trenches. A concrete cattle-dipping vat on the eastern boundary of the APE just south of the stream

channel was not recorded as a site because it does not appear to be very old (mid twentieth century?) and appears to part of a complex of features that are mostly outside the project area on private property. The vat measures ca. 20–25 ft long and just over 4 ft wide; the vat is entirely within the APE, abutting the right-of-way fence (Figure 9). The depth of the vat could not be measured because it is filled in with sediment. Farther north, entirely on private property outside the APE, is a concrete platform that may have been associated with the vat. This platform sits lower than the vat along the creek and is over 100 ft away. It is possible that the concrete rubble observed within the stream channel nearby might be associated as well, with all these features representing a cattle treatment/corral complex.

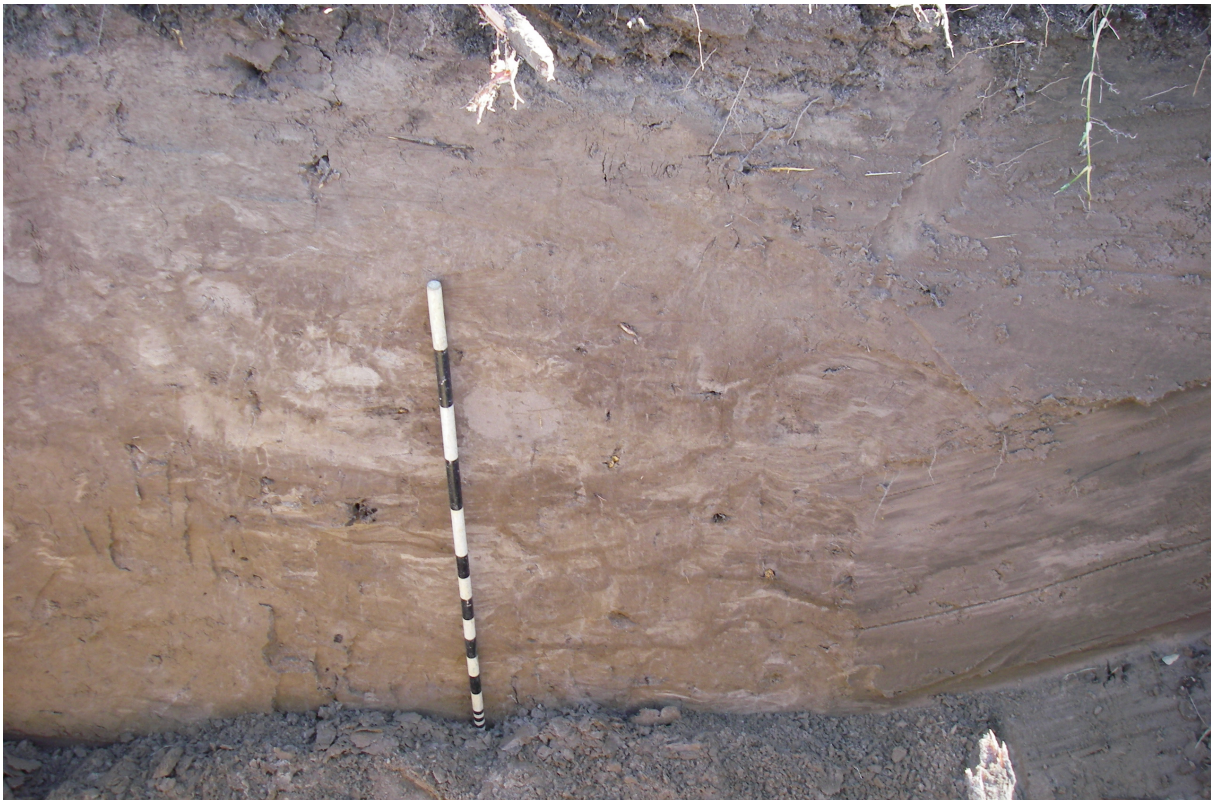
Figure 11. View of the east wall of Trench 3 in the FM 108 project area showing bioturbated sandy sediments containing 41GZ243.

Site 41GZ243 was represented by three chert flakes, two fragments of burned clay, and one pitted and perhaps burned stone found in Trench 3 at the southern end of the APE (all artifacts were photographed and documented and returned to the ground when the trench was backfilled). These materials were found in both walls throughout the length of the 6-m trench. The cultural materials were at a depth of ca. 1.2 m below the surface in dark brown sandy silt alluvium, which underlay ca. 0.2 m of very

dark grayish brown clay loam at the surface. The full thickness of the dark brown sandy silt is unknown, since it extended beyond the bottom of the trench at a depth of 1.7 m. The trench profile displayed extensive bioturbation in the form of root scars and rodent burrows (Figure 11), but the consistent depth of the artifacts suggests that the cultural deposit retains some degree of integrity. No cultural features were observed. All archeological materials observed were within state-owned right of way, and it is unclear if the site extends outside the right of way onto privately owned land. This certainly seems likely, though, particularly to the east based on landform extent. No cultural materials were found in Trench 2, ca. 70 ft from Trench 3 on the west side of FM 108, but this trench did expose similar alluvial sediments with a distinct buried soil at a depth of ca. 0.5 m. Trench 9 about 100 ft north of Trench 3 also contained no cultural materials; the sediments there were different than those in Trenches 2 and 3 to the south in that they had a higher clay content and were overlain by 0.4 m of construction fill. Trench 3 is close to the south end of the APE
